1 **Monitoring horizontal movement of top of a spire in**  
2 **Saint Mary Cathedral of Burgos via computer vision**

15     **Abstract**

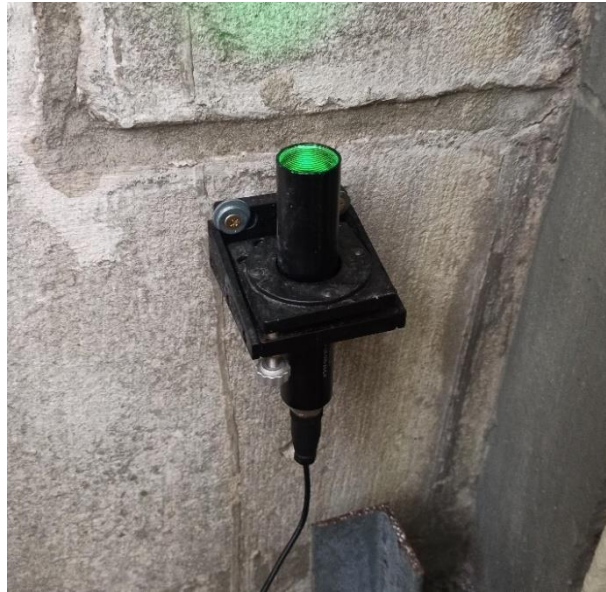
116 **Figure 2.** Laser emitter.

109 Firstly, the fixed part of the system consisted of a single laser emitter because the objective was  
110 to monitor only the displacements; therefore, a single device was sufficient. The emitter used was a  
111 laser module (FP-LR-250-25-C-F, Laser Components GmbH, Olching, Germany). It was a green diode  
112 laser with a wavelength of 520 nm and an output power of 25 mW. The laser was powered by a 220-  
113 V alternating current. Additionally, it was fixed to the needle wall by means of a precision holder  
114 (FP-MP-30, Laser Components GmbH, Olching, Germany) (Figure 2).  
115

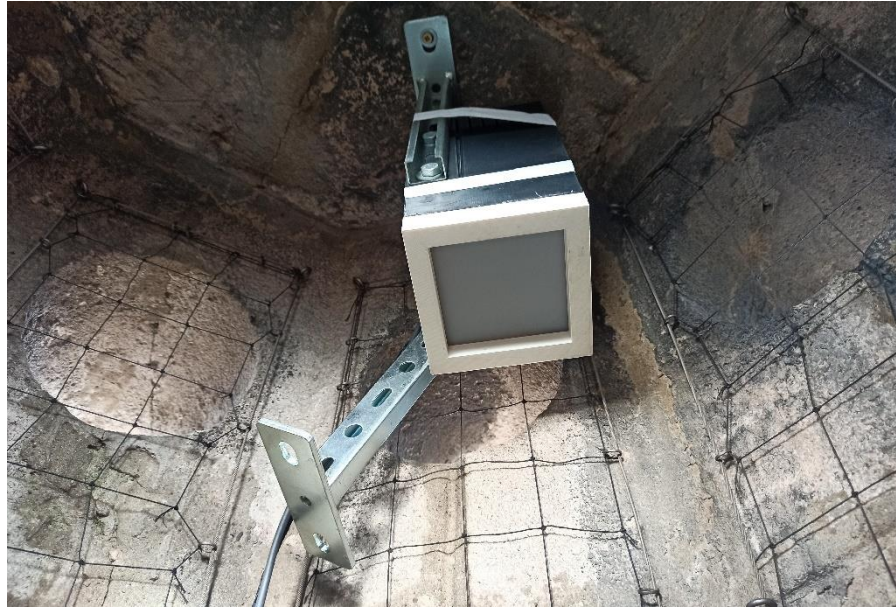
137  
138 **Figure 4.** 3D printed box containing camera and translucent panel.  
139

132 Finally, the camera and translucent panel were housed in a plastic box, creating a compact,  
133 weather-protected unit. This box was designed specifically for this purpose and manufactured from  
134 acrylonitrile butadiene styrene (ABS) using a 3D printing device (Ultimaker S3, Utrecht, Netherlands)  
135 (Figure 4).  
136

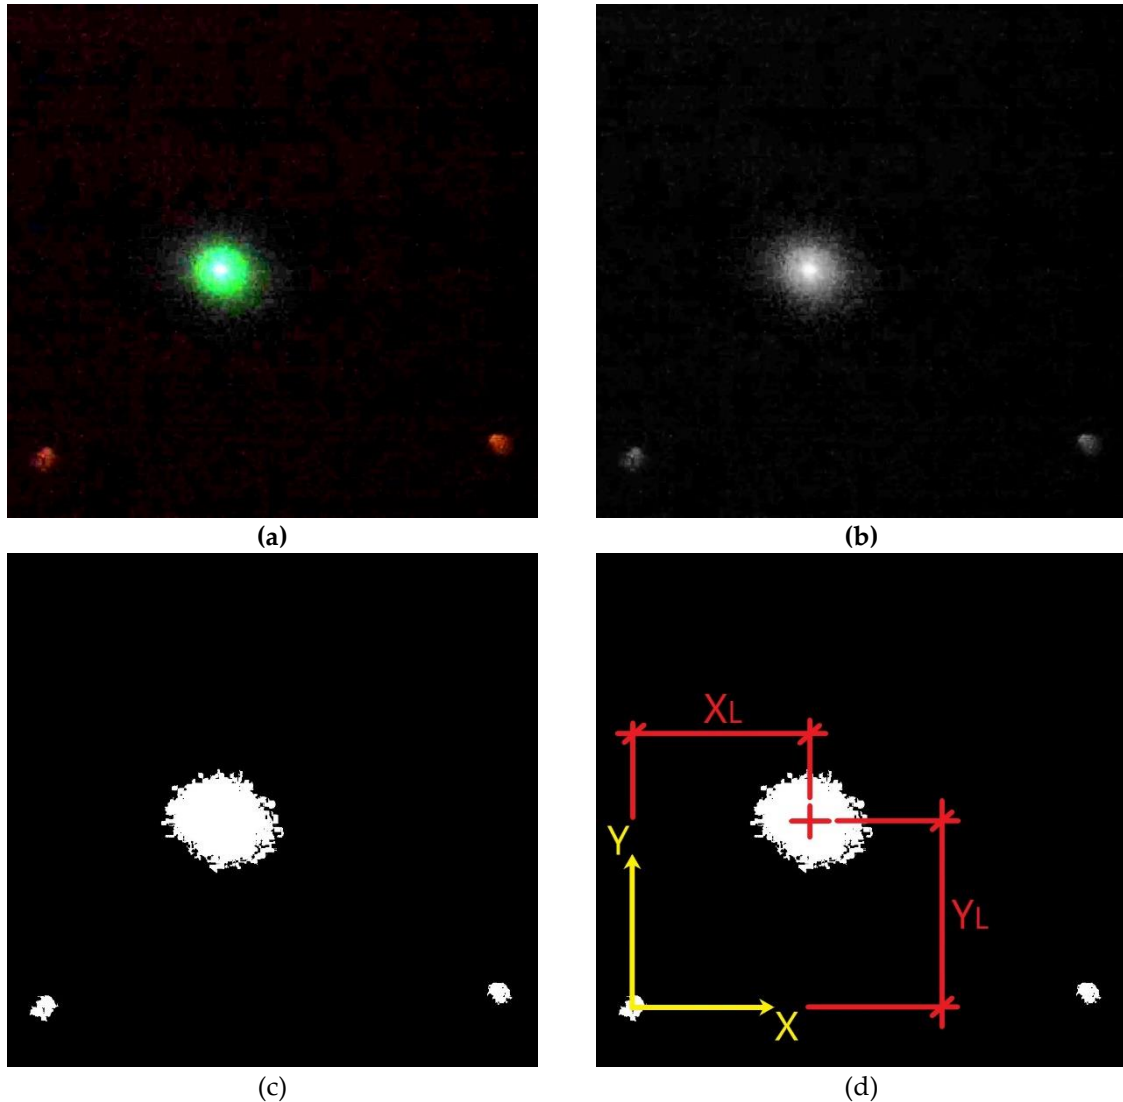
166 **Figure 5.** Algorithm description: (a) original frame, (b) grayscale image, (c) image binarisation,  
 167 and (d) extraction of laser spot centroid coordinates.  
 168

146 Figure 5 shows the implemented algorithm, which is further described below. First, the RGB  
147 images of each frame were transformed into grayscale images. Second, to discretise the three light  
148 sources, a threshold grey value was set so that those pixels whose values were lower than this  
149 threshold were considered "background" while those, whose values were higher, were considered  
150 "light sources". This process is called binarisation, as the pixels that make up the image can only have  
151 two values: 0 (black) or 1 (white). In this case, considering that the greyscale images were 8-bit (i.e.,  
152 the greyscale ranges from 0 to 255), the threshold value was set to 10. Therefore, the pixels with a  
153 grey value in the range 0–10 were considered "background", while those with a value in the range  
154 10–255 were considered "light sources".

155 Third, all the pixels that were part of the same light source were merged. The proximity criteria  
156 were used for this purpose. Next, the coordinates of the centroids of each light source were  
157 determined, taking one of the LEDs as the origin of the coordinate system. In this way, the coordinates  
158 of the laser spot, measured in pixels, were obtained directly. The X- and Y- coordinates of the centroid  
159 of each light source were determined as the mean value of the X- and Y- coordinates of the pixels that  
160 belonged to that light source.

161 Finally, to transform the pixels into mm, a scale factor was calculated, considering that the real  
162 distance between the centroids of the two LEDs was 100 mm. This process was repeated for each  
163 frame. In addition, the algorithm contained filtering tools to eliminate digital noise in the images.  
164 More detailed information can be found in Brown et al. [34].

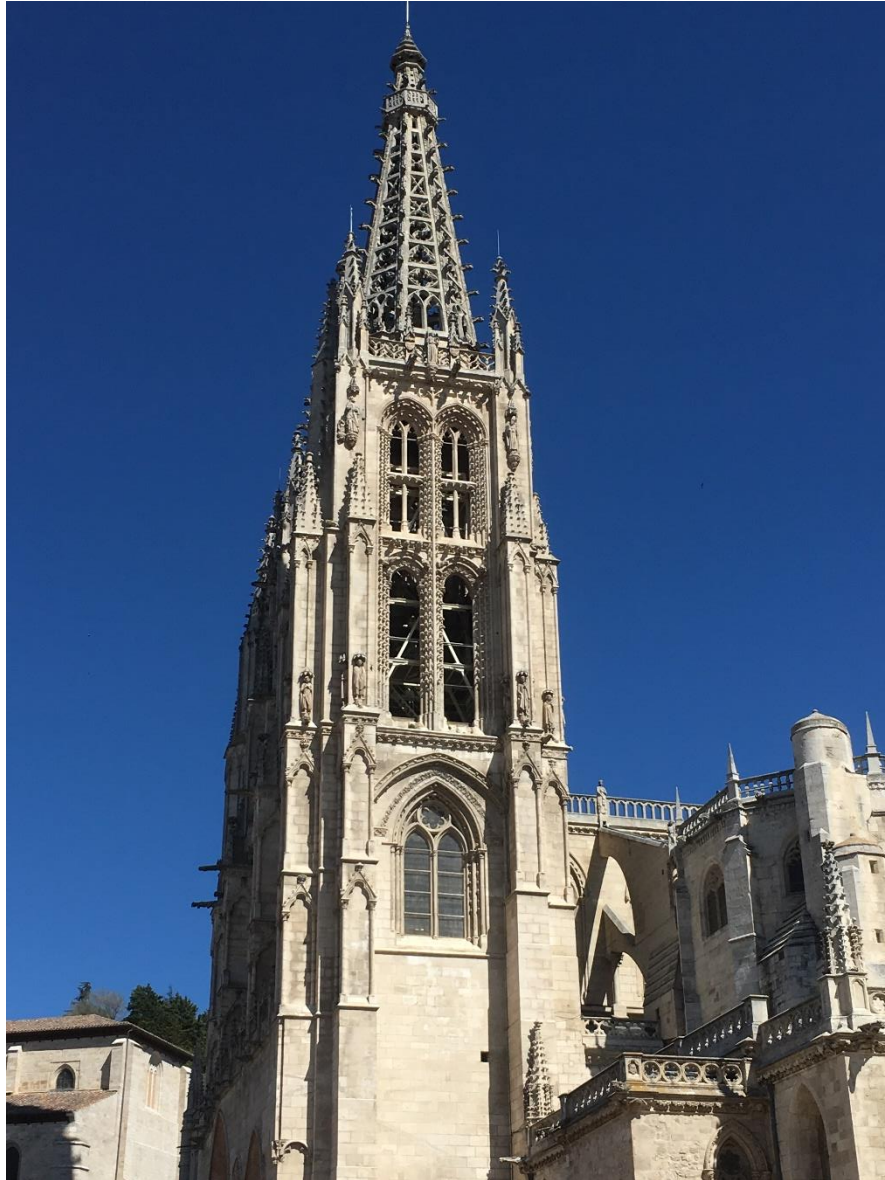
The two spires on the façade of Santa María (Figure 7) stood out for their height. These elements date back to the 15th century and were designed by the German architect Johannes von Köln (Cologne, Germany, 1410 – Burgos, Spain, 1481).

190  
191 **Figure 7.** General view of the south spire placed on the façade of Saint Mary Cathedral.  
192

193 The temple is now in an excellent state of conservation, particularly the spires. Therefore, it is a  
194 suitable infrastructure for testing the proposed system for monitoring horizontal movements based  
195 on computer vision.

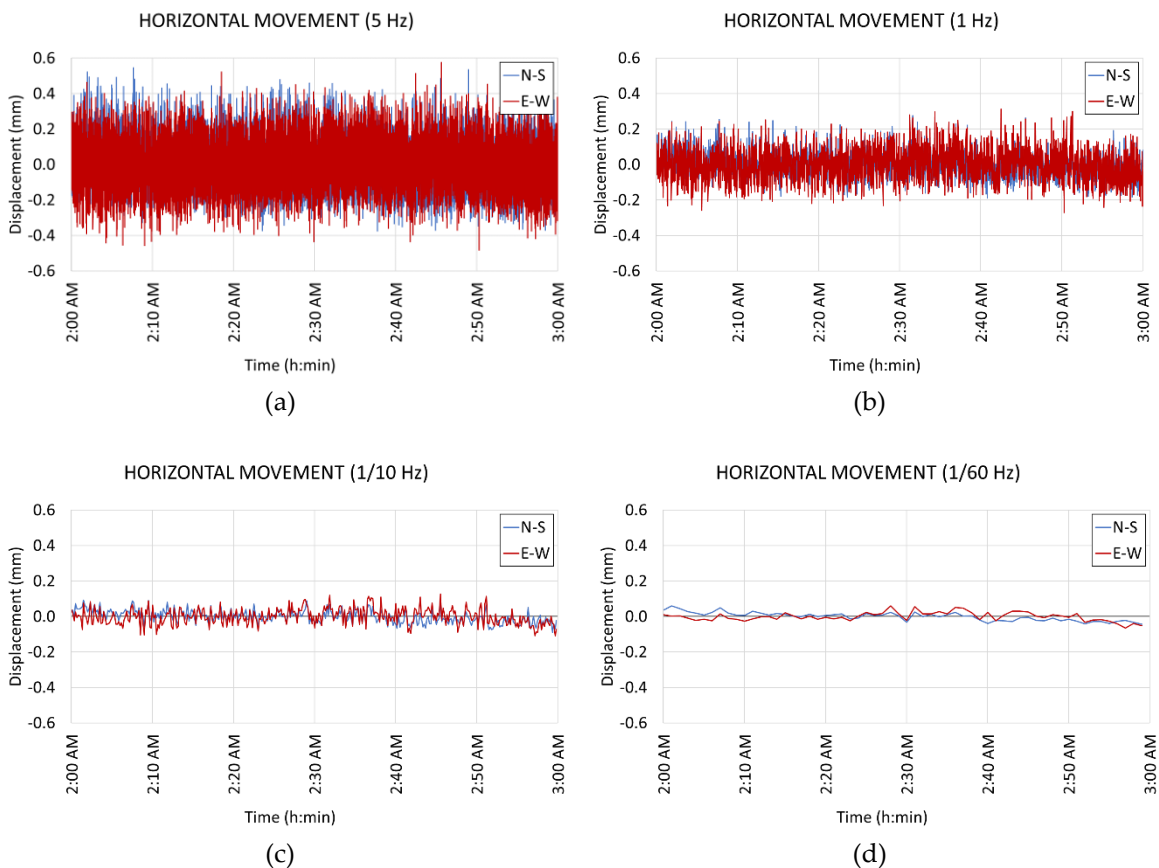
280 **Figure 12.** White noise at different recording frequencies (Hz): (a) 5, (b) 1, (c) 1/10, and (d) 1/60.

269 In the early morning of 23 February, 2021 a one-hour monitoring was carried out (between 2:00  
 270 AM and 3:00 AM), during which the environmental conditions were very stable. The temperature  
 271 was particularly stable in this time slot, with a mean value and maximum variation of 4 and 0.3  $^{\circ}\text{C}$ ,  
 272 respectively. There was a light, steady, south-westerly wind with a wind speed between 4 and 8 km/h.  
 273 Therefore, the environmental conditions were ideal for evaluating the white noise of the LVBBDT  
 274 sensor.

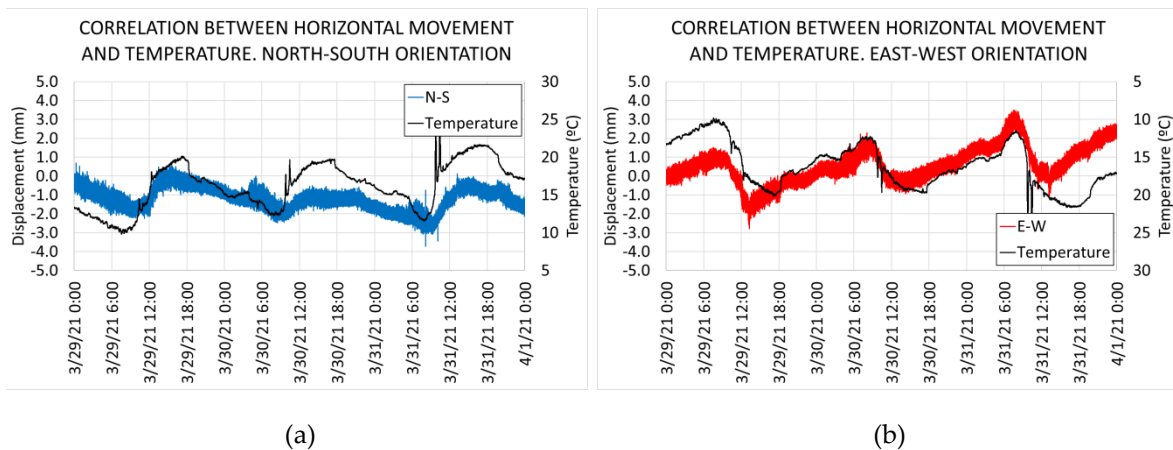
342 **Figure 14.** Correlation between horizontal movement and temperature: a) north–south  
 343 orientation and b) east–west orientation.  
 344

340 When the temperature and horizontal displacements were superimposed, a clear correlation  
 341 could be obtained (figure 14).

345 In summary, the thermal variations experienced by the spire caused a horizontal movement at  
 346 its top as well as rotation. As observed, the horizontal movements were of the order of a few mm,  
 347 while the rotation was only of a few hundredths of a deg. The LVBDT sensor, which had an accuracy  
 348 of approximately  $\pm 0.2$  mm for a sampling rate of 1 Hz (see Table 2), could accurately measure  
 349 movements of a few mm. However, the inclinometer, which had an accuracy of  $\pm 0.01^\circ$ , did not  
 350 adequately record rotations of a few hundredths of a deg.

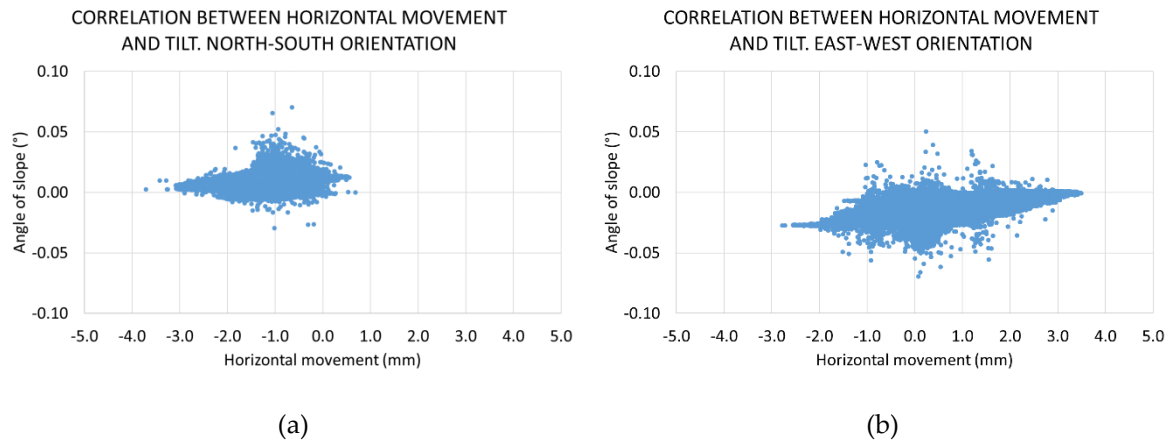
361 **Figure 15.** Correlation between horizontal movement and slope: a) north–south orientation  
 362 and b) east–west orientation.  
 363

359 Figure 15 shows the correlation between the tilt of the tower and its horizontal movement.  
 360

364 In both the north–south (Figure 15a) and east–west directions (Figure 15b), a clear relationship  
 365 between both the parameters was observed, which was understandable from a structural point of  
 366 view. In both the cases, the fitting curves were noticeably horizontal, which meant that small turns  
 367 were correlated with large horizontal movements. Given the technical characteristics of both the  
 368 inclinometer and LVBDT, it was found that the latter was more sensitive than the former.

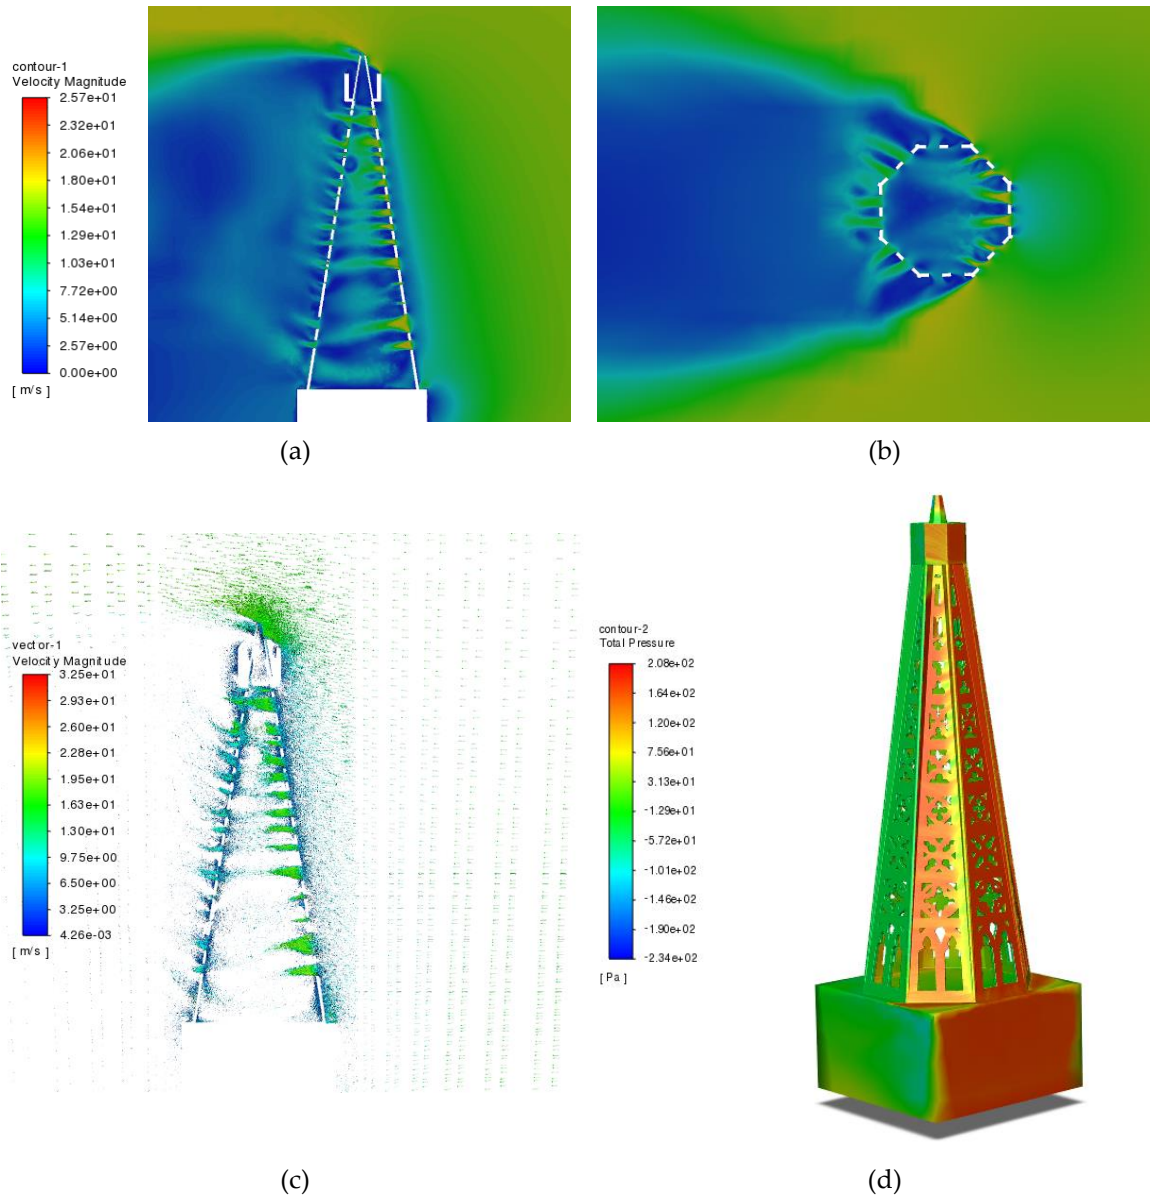
428 **Figure 18.** Key results from the CFD model: (a) wind speed distribution – elevation view, (b)  
 429 wind speed distribution – plan view, (c) wind orientation, and (d) wind pressure on the spire.

422 In addition, a numerical model was developed to estimate the theoretical values of the horizontal  
 423 motion of the spire head. Firstly, a computational fluid mechanics (CFD) model was developed,  
 424 considering a uniform wind flow with a velocity of 60 km/h, which approximately coincided with  
 425 the maximum wind values recorded during the wind event (Figure 17b). Figure 18 shows key results  
 426 from the CFD model employed.  
 427

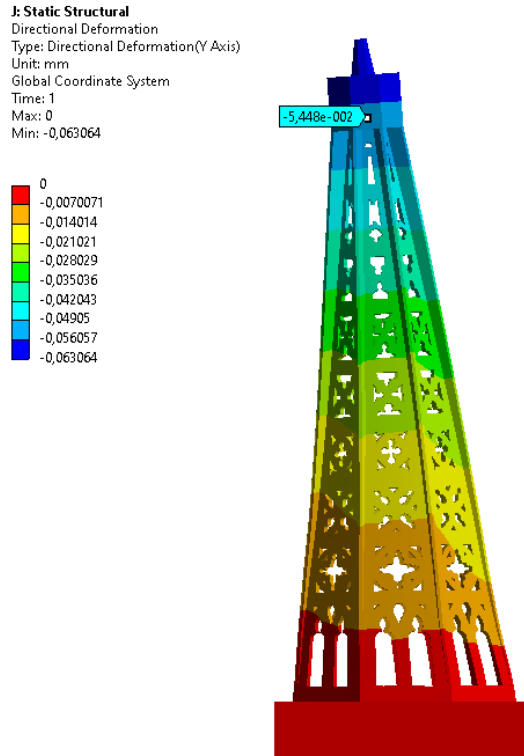
**Figure 19.** Horizontal movement of the spire caused by wind, as obtained from the FE model.

430  
 431 From the CFD model results, a mechanical model was developed to determine the horizontal  
 432 movement of the spire (Figure 19).  
 433

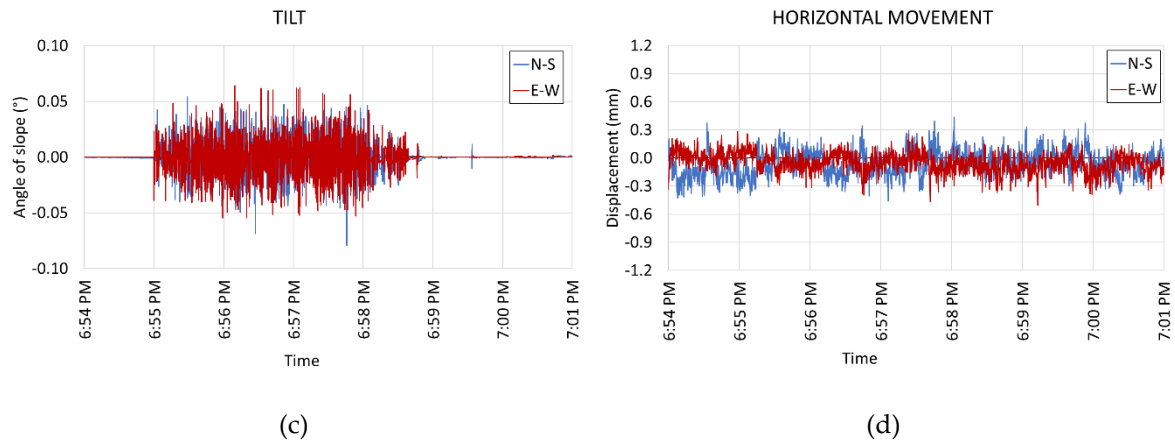
451 **Figure 20.** Measurements during the induced vibration event: (a) acceleration at the base of the  
 452 spire, (b) acceleration at the top of the spire, (c) tilt, and (d) horizontal movement.

The induced vibration event took place during the ringing of the bells on 25 May, 2021 which lasted approximately 3 min. The two bells were located under the monitored spire. In this case, the thermocouple and anemometer data were not included, as the duration of the event was too short for the temperature and wind to have a significant effect. It should be noted that the average temperature was 17.5 °C and the average wind speed was 5 km/h, with no notable gusts. On the other hand, the accelerations at the base and top of the spire were included (Figure 20).

453  
 454 The accelerations at the base and top of the spire are shown in Figures 20a and b, respectively. It  
 455 can be observed that the vibrations generated by the bells caused much higher accelerations at the  
 456 apex than at the base. Again, this was to be expected because the behaviour of the spire is equivalent  
 457 to that of a cantilever, and therefore, the greatest movements and accelerations would occur at its free  
 458 end. In this case, since it was a short-term measurement, the sampling rate of the accelerometers was  
 459 50 Hz.

460 Figure 20c shows the tilt at the top of the spire. Similar to the case of wind, the bells caused high-  
 461 frequency vibrations without a predetermined direction. In this event, the amplitude in terms of tilts  
 462 was slightly higher, with an average range of  $\pm 0.06^\circ$ .

463 Finally, Figure 20d shows the horizontal displacement recorded by the LVBDT. Again, the  
 464 results reveal that the sensor could not record the high frequency and very low horizontal  
 465 displacement caused by the ringing of bells. Therefore, it was inferred that the major application of  
 466 the LVBDT was the monitoring of low-frequency displacements.

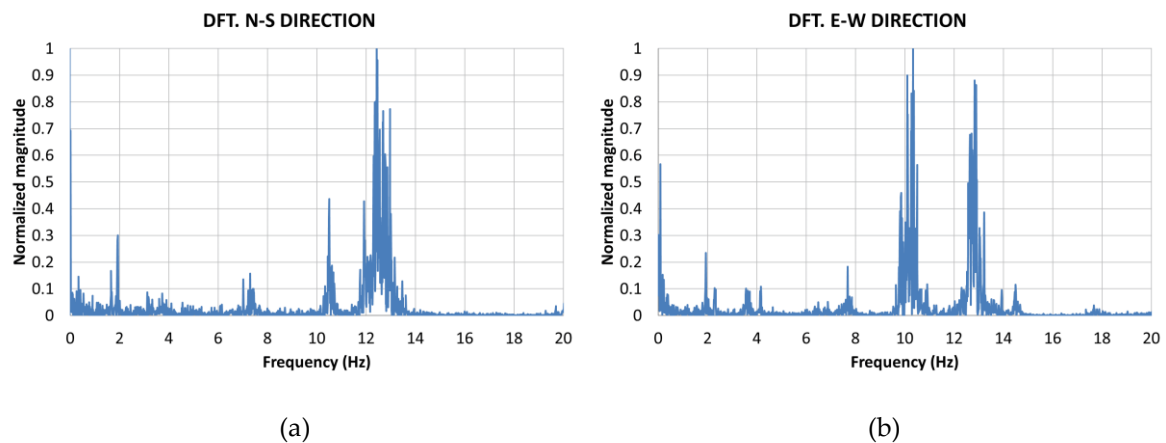
469 **Figure 21.** DFT results from field study: (a) North-South direction, and (b) East-West direction.

467 Additionally, A DFT was performed on the data recorded by the accelerometer placed at the top  
 468 of the spire to identify dominant frequencies within the recorded data (Figure 21).

470  
 471 Figure 21a shows that, in the N-S direction, the main natural frequency is 12.43 Hz. Another  
 472 relevant peak frequency can be observed at 10.50 Hz. On the other side, in the E-W direction, the  
 473 main natural frequency is 10.33 Hz, while the other relevant peak frequency can be observed at 12.83  
 474 Hz.

485 A comparison of the theoretical natural frequency (obtained from the FEM) with the measured  
 486 natural frequencies (see Figure 21) shows that the latter are slightly higher than the former, which  
 487 reveals that the structure is stiffer than that predicted by the model.

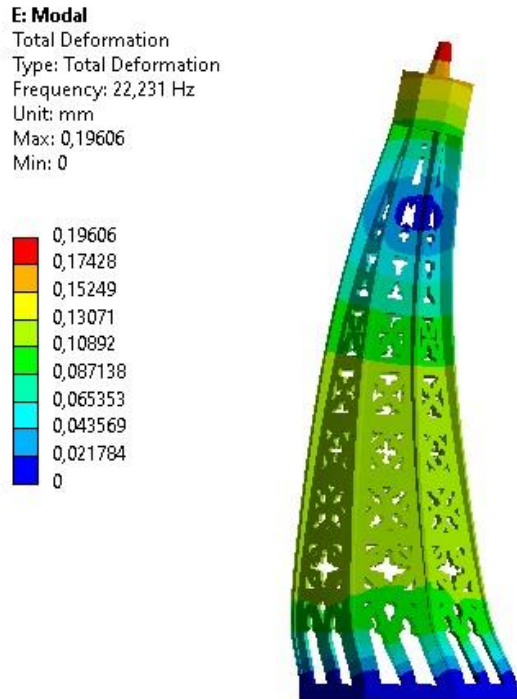
**Figure 23.** Fifth mode of vibration of the spire and its corresponding frequency, as obtained from the FE model.

495  
 496 Table 3 shows that the first mode mobilised a significant part of the total mass (45.9%). The other  
 497 important mode was mode 5, which mobilised an additional 30.8%. Figure 23 shows the fifth mode  
 498 of vibration.
