ANALYSIS OF UNIVERSAL ACCESSIBILITY AT PUBLIC TRANSPORT STOPS IN THE CITY OF CÁCERES

The study proposed in this article aims to analyse the situation of public transport stops in the city of Cáceres following the criteria required by current legislation on universal accessibility, trying to identify the architectural barriers encountered by users of the service who have some physical limitation.

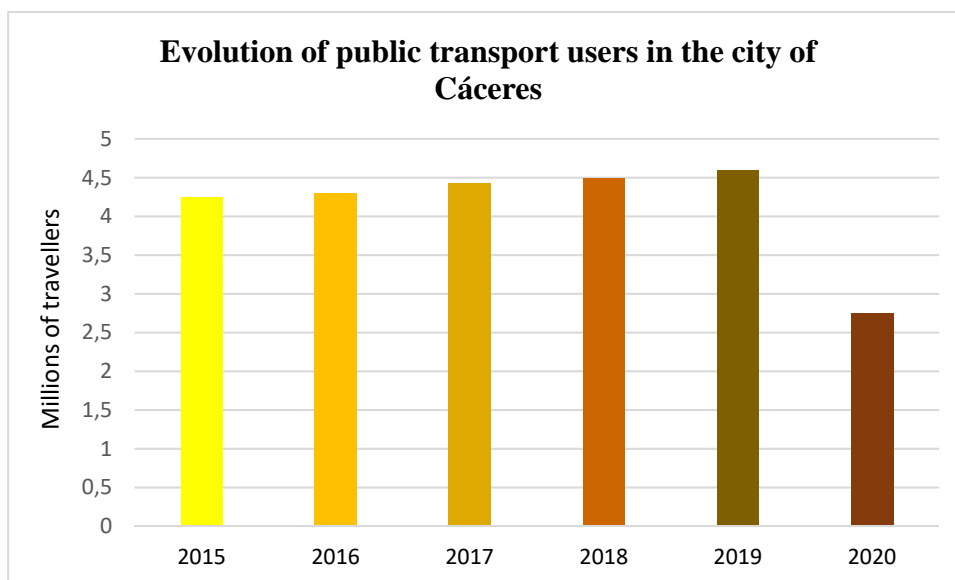
Figure 2 shows the evolution of urban transport passengers over the last 6 years in the city, showing a gradual increase of users using the bus from 2015 to 2019, gaining 355,115 passengers, an increase of just over 8% in 5 years. However, in 2020, ridership plummeted due to the COVID-19 pandemic, with a decrease in ridership of almost 40% compared to 2019.

Fig. 2 – Bus passenger registration in Cáceres

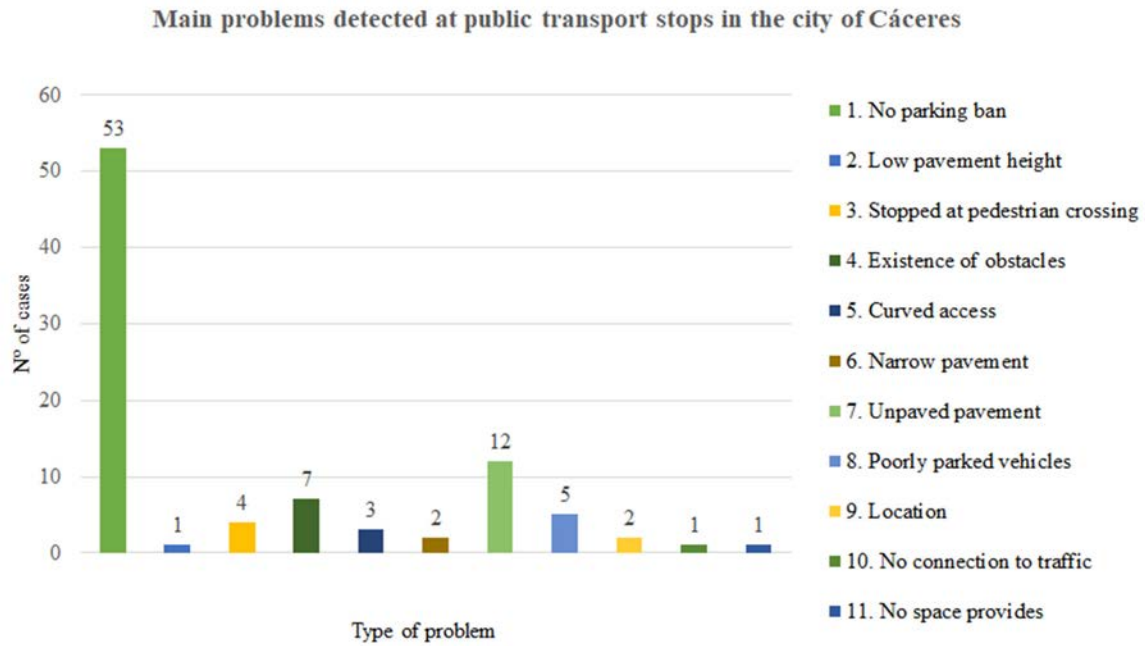
Fig. 3 – Type of problem

The most frequently repeated problem is the lack of parking bans (58% of cases) or, if they exist, they are not correctly signposted. The study shows that a large part of the non-compliances found are due to a lack of planning, as a result of the successive extensions of the network itself in order to solve the problems that have arisen over time in each neighbourhood.

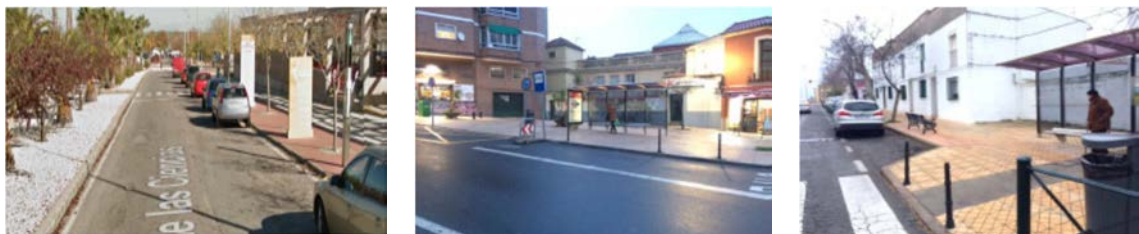
Fig. 4 – Problems type 1, 2, 3

The picture above shows problem typologies 1, 2 and 3. The photograph on the left shows a stop on the university campus with no parking ban for private vehicles, which means that this space is not usually available for buses to approach. It is proposed that the corresponding vertical and horizontal signage be installed to identify the space reserved for public transport. The central image shows a common problem in many cities: the pavement is not high enough for the bus to kneel down. In this case, it is proposed to increase the height of the pavement to 20 cm by means of an anti-slip pavement. The photograph on the right (at 54 Bondad Avenue) shows an undesirable image, the bus stop is located in the middle of a pedestrian crossing. It is felt that it would be appropriate to dispense with the two adjacent parking spaces, widening the pavement in that area and moving the bus shelter away from the zebra crossing and allowing pedestrians to move freely.

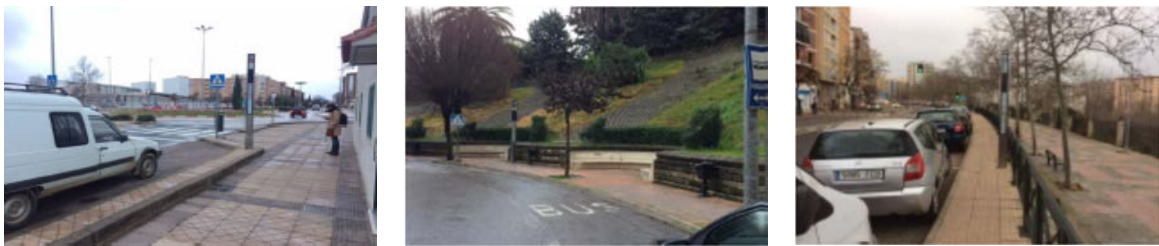
Fig. 5 – Problems type 4, 5, 6

The previous figure on the left shows the impossibility of approaching urban transport to the pavement, which is not accessible to people with reduced mobility. The problem is solved by raising the raised kerb to the edge of the road, gaining the necessary area for the location of the stop, which is connected to the pedestrian route by means of a small ramp.

The central image shows that the public transport access is curved. In order to allow the correct approach of the bus, parking is prohibited in the adjacent area, which provides extra space for the vehicle's turning manoeuvre. In the upper right image, a pavement is evaluated that does not comply with the regulations (it is less than 120 cm wide) and does not have a connection for people with reduced mobility. The proposed redefinition of the stop consists of widening the pavement by building a much wider cantilevered platform that connects to the lower level by means of an accessible ramp.

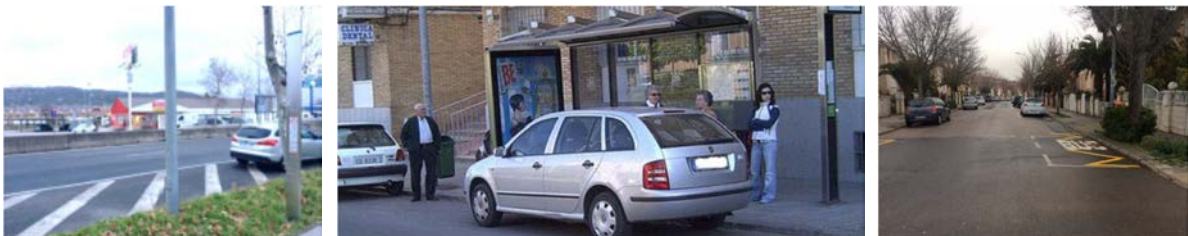
Fig. 6 – Problems type 7, 8, 9

The top left image shows a green area between the pavement and the road, making it impossible for a person with reduced mobility to access the bus. To solve the problem, the pavement should be extended to the edge of the road, thus creating a platform that would allow guaranteed access to urban transport. The central image shows a common inconvenience at bus stops, the indiscipline of the private vehicle driver. The construction of a raised reserved area extending from the pavement to the road would solve the problem. On the other hand, the upper right image shows an example of a poor location of a bus stop immediately after a curve and without a pedestrian crossing nearby, the solution to which is to move it just before the curve (in a straight area), allowing the construction of a bus shelter before a pedestrian crossing.

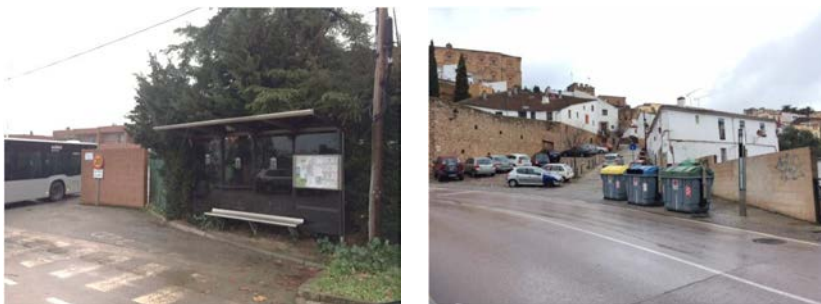
Fig. 7 – Problems type 10, 11

Figure 7, left-hand side, shows a disconnection with traffic, which could be solved by completing the pavement in the stop area and moving the bus shelter to the centre of this area. On the right-hand side of the image there is no space specifically designated for public transport stops. A rearrangement of the area is proposed, defining an entrance area where the minibus providing the service can stop and turn around by means of a semi-curve. In this way, the bus will not stop in the middle of the street and there will be an area for pedestrians from which the bus can be properly accessed.
