Effects of temperature and moisture fluctuations for suitable use of raw-crushed wind-turbine blade in concrete

Keywords Raw-crushed wind-turbine blade · Concrete · Moist/dry test · Alternating-sign temperatures · Thermal shock · Multiple-regression statistical prediction

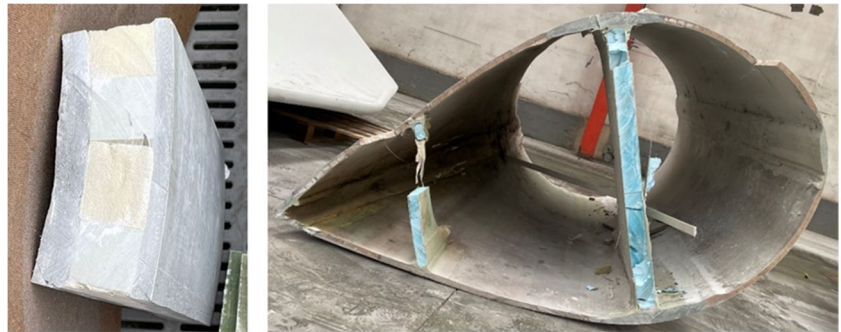
Fig. 1 Sandwich panel (left) and section (right) of a decommissioned wind-turbine blade

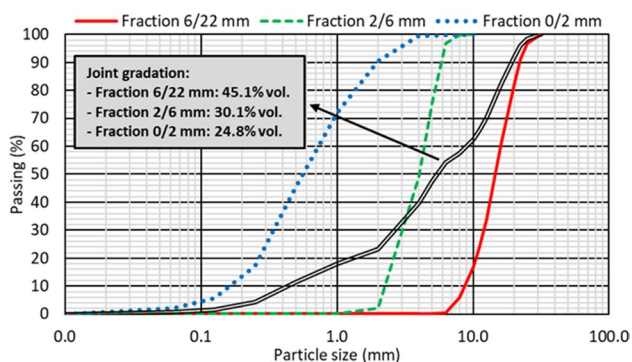
Fig. 2 Individual and joint gradation of crushed siliceous aggregate fractions

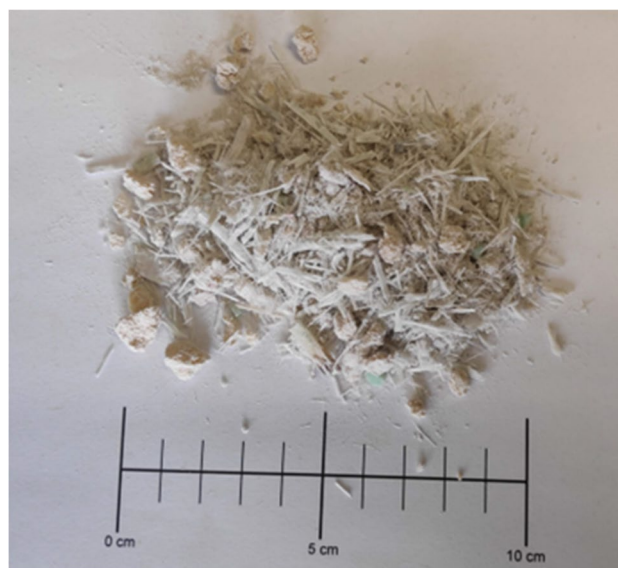
Fig. 3 Raw-crushed wind-turbine blade

particles (Fig. 3) that had turned black. Together with the expected decomposition of ettringite, the test conditions might have weakened the adhesion between the balsa-wood particles and the cementitious matrix within the interfacial transition zones (Revilla-Cuesta et al. 2023a). A reduction in concrete strength was therefore linked to both the melting of the polyurethane particles and the burning of the balsa-wood particles.

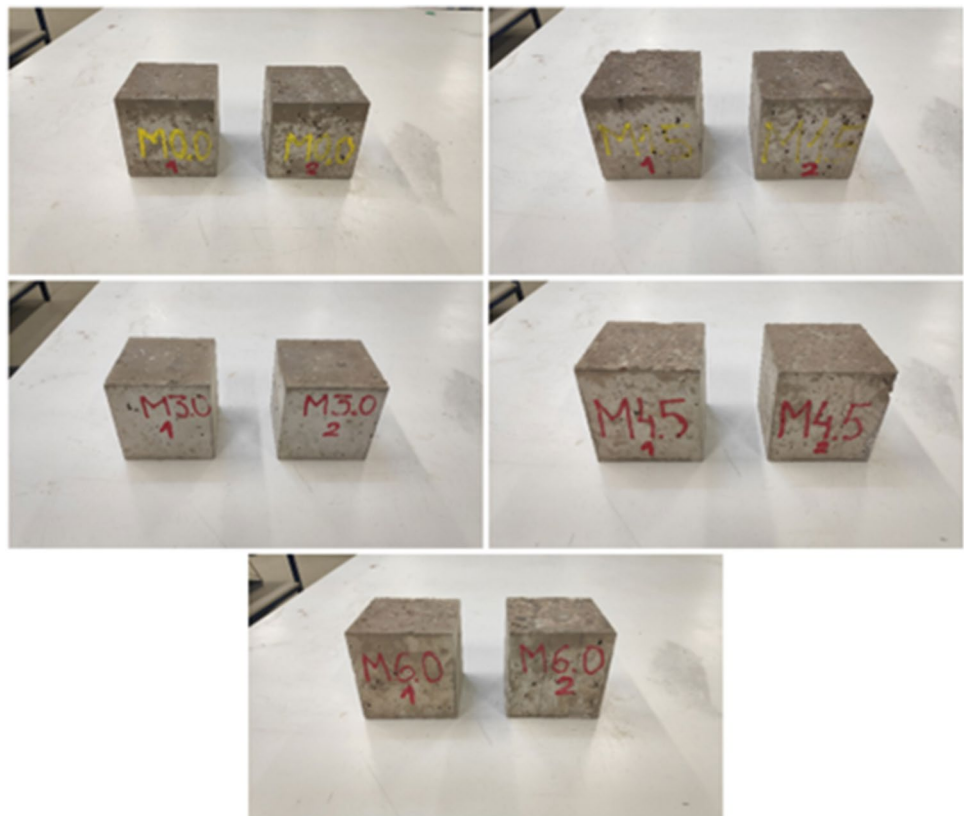
Fig. 5 External appearance of two representative specimens per concrete mix after the moist/dry test

Cubic specimens of the five concrete mixes were subjected to a moist/dry test as described in the “Experimental procedure” section. At the end of the test, the concrete specimens showed no visible signs of damage, as shown in Fig. 5, except for some dark colored marks due perhaps to deterioration of the specimen skin (Santamaría et al. 2020) and a slight rounding of the corners. However, the computation of the specimen weight and the UPV readings every five cycles pointed to progressive damage to the concrete throughout the test:

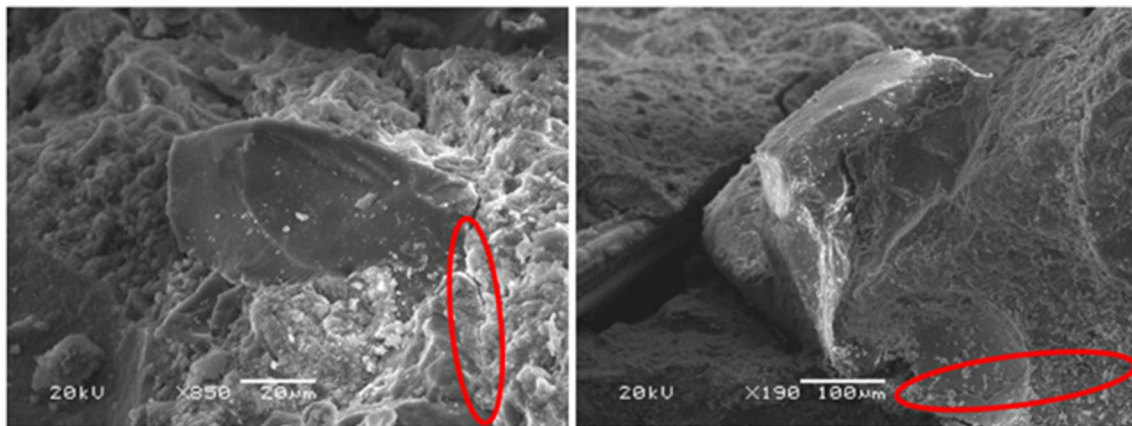
**Fig. 7** SEM analysis after the moist/dry test (micro-cracks encircled in red): *M4.5* mix (left) and *M6.0* mix (right)

- SEM analyses performed after completion of the test (Fig. 7) on concrete fragments of the *M4.5* and *M6.0* mixes, the ones with the highest damage, verified the existence of micro-cracking that appeared primarily in the interfacial transition zones. Furthermore, it seemed that these micro-cracks were subsequently easily propagated through the pores. This reinforced the conclusions on internal damage derived from the analysis of weight and UPV evolutions throughout the moist/dry test.

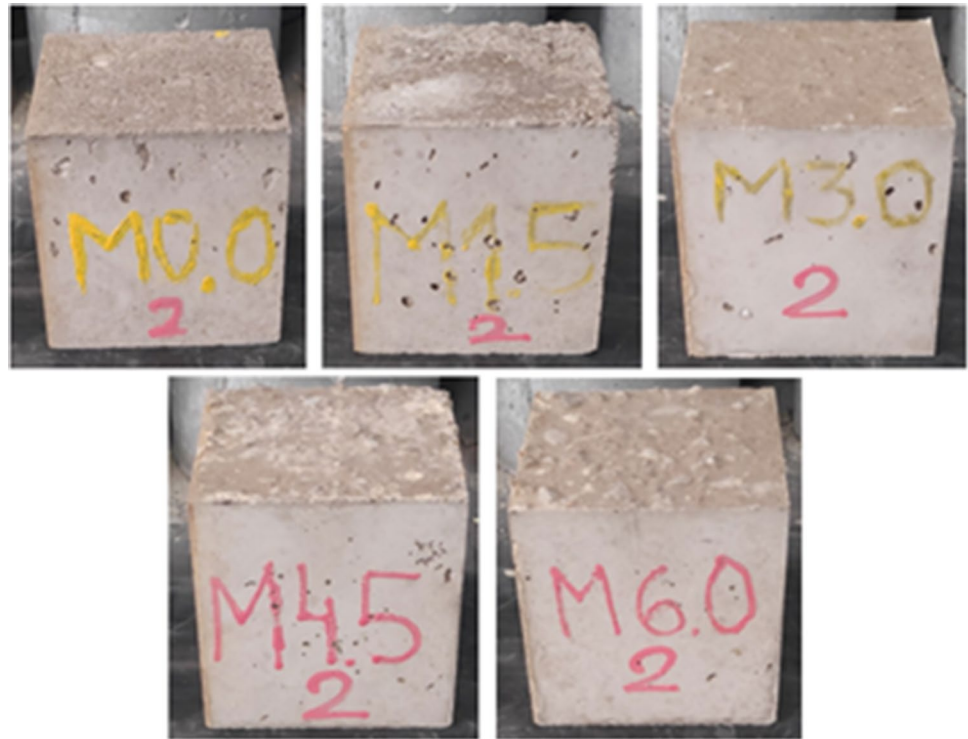
Fig. 8 External appearance of a representative specimen after the 20-cycle alternating-sign-temperature-shock test

At the end of the test, the specimens showed no external signs of deterioration (Fig. 8), but did internal damage (Fig. 9). The increased weight of the specimens (Figs. 10a and 11a) and their lower UPV readings (Table 4 and Figs. 10b and 11b) throughout the test did show the appearance of that internal damage in the concrete (Jones 1963), similar to what was found in the moist/dry test. The micro-cracking that appeared followed the same pattern as in the moist/dry test, although in this case cracking was also detected in some areas of the bond between the cementitious matrix and the GFRP-composite fibers. This phenomenon can be seen in Fig. 9, an image obtained through SEM analysis of a fragment of the *M4.5* mix after the 20-cycle alternating-sign-temperature-shock test, and may be due to the application of negative temperatures (Revilla-Cuesta et al. 2023a).

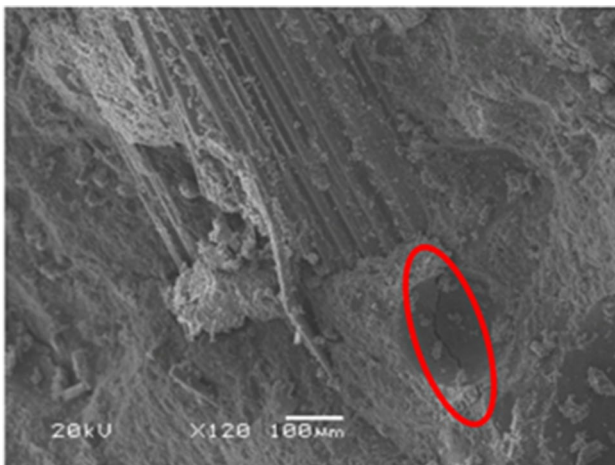
Fig. 9 SEM image of the *M4.5* mix after the 20-cycle alternating-sign-temperature-shock test (micro-cracks encircled in red)

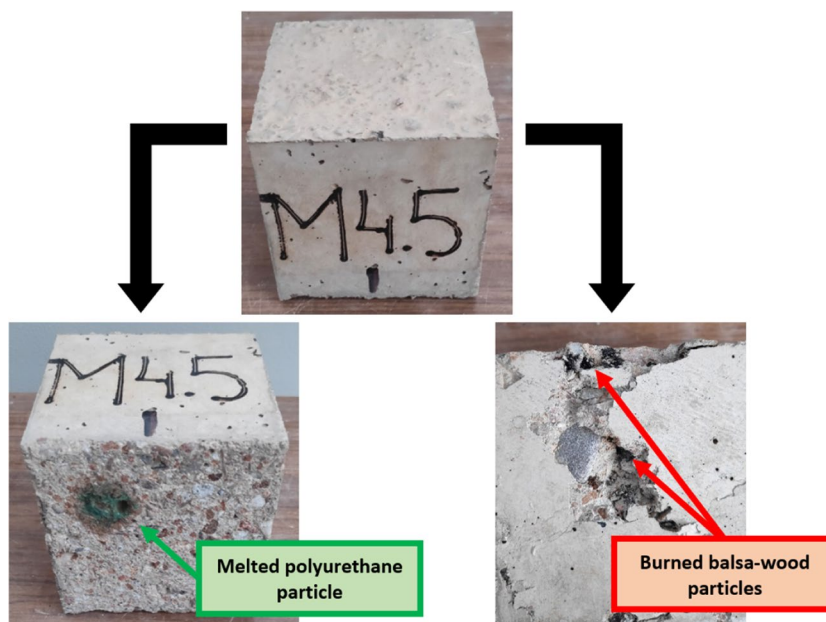
Fig. 12 Visual analysis of the effects of the high-temperature-shock test on the components of RCWTB

The first aspect to be discussed is the visual analysis of the specimens conducted after the 7-day high-temperature-shock test. For this purpose, the skin was removed from the underside of some specimens before testing them under compression. In addition, the specimens were visually evaluated after breakage. No alteration of the characteristics of the GFRP-composite fibers was visible to the naked eye, but the other two RCWTB components were clearly affected, as shown in Fig. 12. Firstly, the polyurethane particles located in the outermost area of the specimens melted, leading to an increase in the macro-porosity of the concrete specimens (Ozturk et al. 2023). Then, it was observed that the high temperatures had burned the initially brown-colored balsa-wood

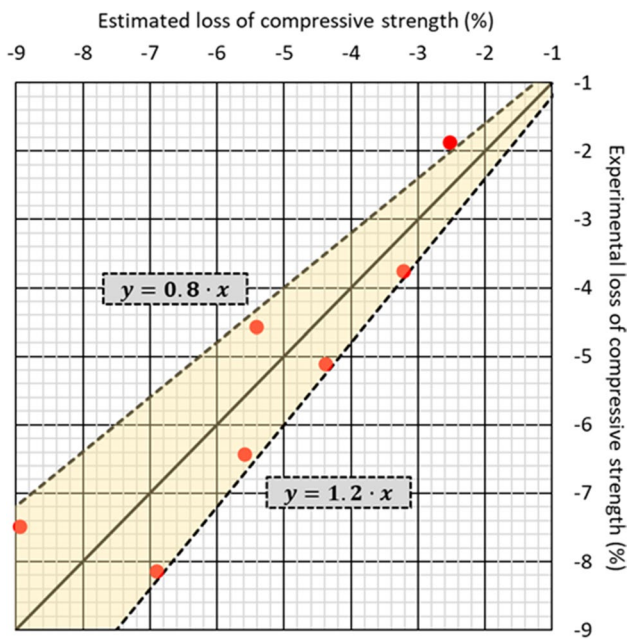
Fig. 14 Comparison of experimental and estimated losses of compressive strength during the high-temperature-shock test

A linear multiple-regression model was developed to corroborate the existence of this interaction and to predict the variation of the compressive strength (ΔC , in %) from the exposure time (t , in days) at high temperatures, in this case 200 ± 5 °C, and the RCWTB content of the concrete (c_{RCWTB} , in %). This model is detailed in Eq. (1), which presented an R^2 coefficient of 84.24%. It can be noted that the prediction of the effect of thermal exposure on the RCWTB

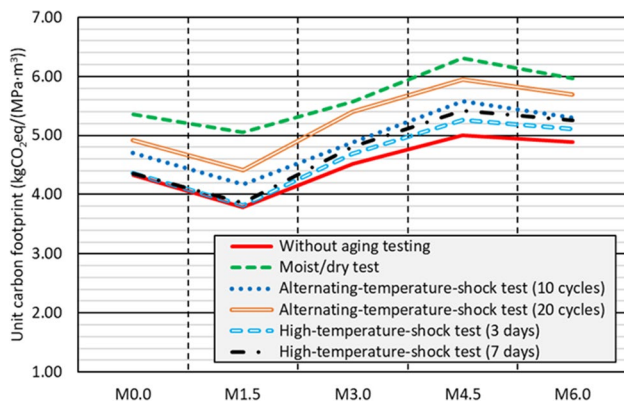
Fig. 15 Carbon footprint per unit of compressive strength after each test

(Yang et al. 2015; Hossain et al. 2016; Rebello et al. 2019; Revilla-Cuesta et al. 2024), and Q is the content of each raw material in the concrete in kg/m^3 , values that are depicted in Table 2. The carbon footprint was always reduced when increasing the RCWTB content (Revilla-Cuesta et al. 2024). Based on this, the carbon footprint per unit of compressive strength of the concrete mixes ($CF_{c,CS}$, in $\text{kgCO}_2\text{eq}/(\text{MPa}\cdot\text{m}^3)$) was obtained through Eq. (3), in which CS is the compressive strength in MPa (Hosseini et al. 2022). The residual compressive strength after testing was used in this research. Figure 15 shows the unit carbon footprint for each test and mix.

The unit carbon footprint followed a similar trend in all the tests, decreasing when 1.5% RCWTB was added. This was possible due to the decrease in cement content and the improvement of the concrete behavior under moisture and temperature fluctuations thanks to the GFRP-composite fibers (G. T. Xu et al. 2022a, b; Hamada et al. 2023). The increased content of balsa-wood and polyurethane particles with the addition of higher percentages of RCWTB led to a larger loss of compressive strength after testing, so that the $M0.0$ and $M3.0$ mixes had the same unit carbon footprint, which was even higher in the $M4.5$ mix, despite the decrease of cement content per m^3 in the concrete. The bridging effect of the GFRP-composite fibers was more successful in the $M6.0$ mix, which led to a reduction in the unit carbon footprint. Finally, concrete exhibited a better environmental performance when exclusively exposed to high temperatures, as the combination of high temperatures and large moisture variations caused the highest deterioration of compressive strength.
