Anales de Edificación
Vol. 10, Nº1, 54-65 (2025)
ISSN: 2444-1309
DOI: 10.20868/ade.2025.5401

Estudio energético para la rehabilitación de la antigua Abadía de Salas de Bureba (Burgos) para uso residencial. Caso de estudio

Energy study for the rehabilitation of the old Abbey of Salas de Bureba (Burgos) for residential use. Case study

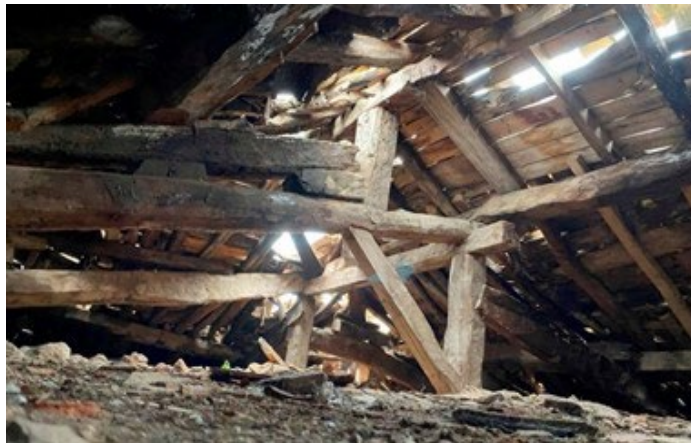
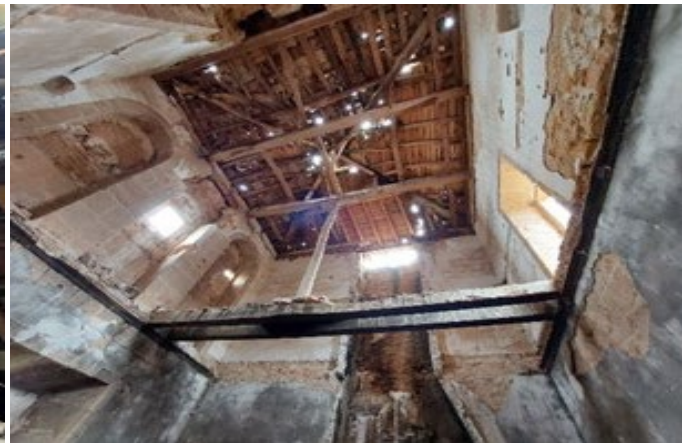
Fig. 4 and 5: Wood structure of the roofs and interior of the Tower. (Source: Paula Montoya Saiz)

It is estimated that the roof is built on four sides with solid wood beams, the covering element is completed with pairs and shingles on which are tiles placed in the traditional style, without receiving. There is no clear truss system, and a precarious structure has been built to support the inclined beams, as can be seen in Figs. 4 and 5.

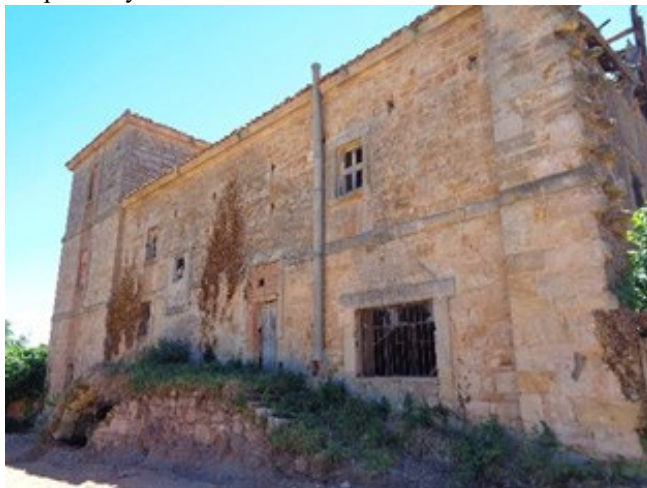
Fig. 6: North façade with tower and west end. (Source: Imanol Ruiz de Vergara Ruiz de Azúa)

The west end has an unfinished roof with a lattice wall element, as if it had intended to extend the building on that side, as can be seen in Fig. 6.

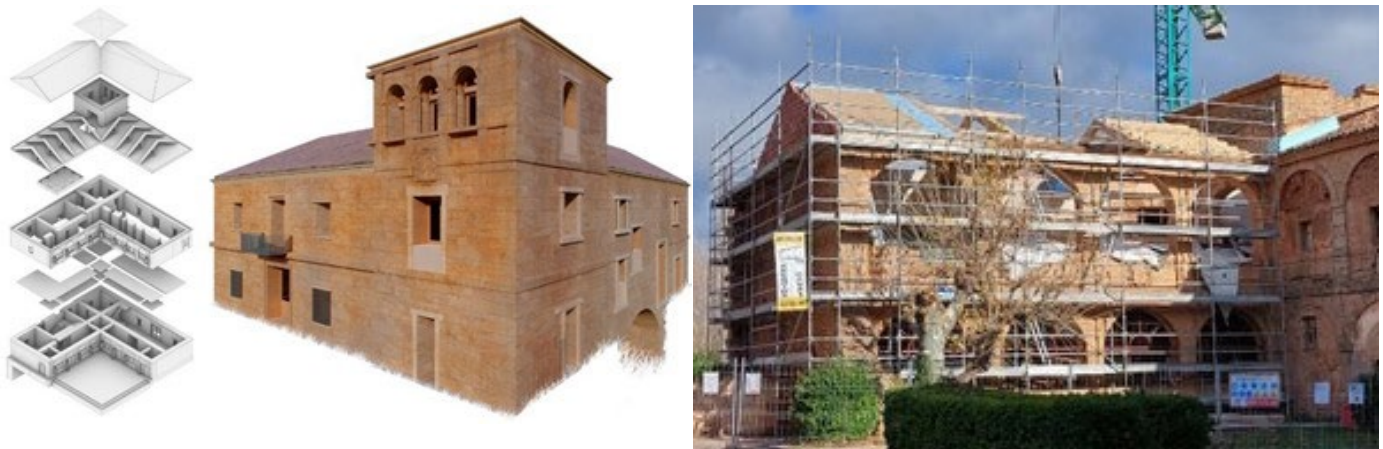
Fig. 7 and 8: 3D models of the building in its rehabilitated state, and state of the works in the North-South wing. (Source: Paula Montoya Saiz)

This project, the implementation of which has already begun, has obtained a double A energy rating, which has allowed it to qualify for aid from the PREE 5000 Programme (MITERD 2021). Fig. 7 and 8 show two 3D simulations with the structure and appearance of the building once rehabilitated, as well as the status of the works at the end of 2022.
